MSF evaporator materials evaluation after 20 years in service

Saleh A. Al-Fozan*, Anees U. Malik

Saline Water Desalination Research Institute, Saline Water Conversion Cooperation, PO Box # 8328, Al-Jubail 31951, Kingdom of Saudi Arabia

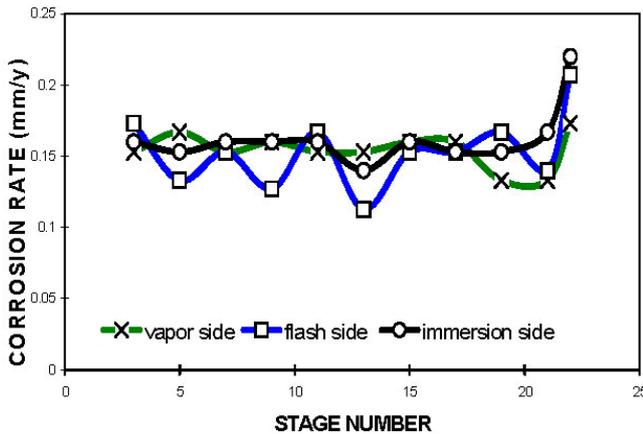
The corrosion rate was calculated based on thickness measurement on division and side walls. The calculations were made at three different locations, namely, brine, flash and vapor sections. Table 3 provides the maximum corrosion rate values at different locations of flash chamber. Figs. 1 and 2 show the corrosion behavior of two different desalination units at three locations. In general,

the average corrosion rates of the flash chambers at the three locations are in the design range with different characteristics in individual stages. The corrosion rate measurements of flash chambers show that the corrosion rates in vapor zone were in the same range for all the stages with a slight increase in stage #3 and the last stage. In the flash zone, the highest corrosion rate was observed in the last stage and fluctuated in the other stages.

Fig. 1. Corrosion behavior of flash chamber in different stages on the basis of thickness measurement (Desal #3, C-5).

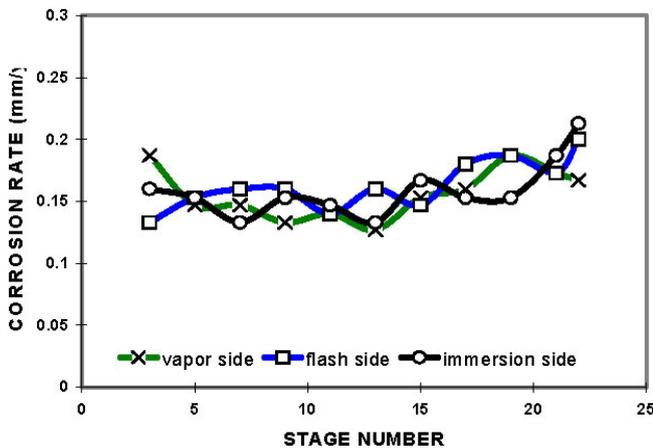
Fig. 2. Corrosion behavior of flash chamber in different stages on the basis of thickness measurement (Desal #21, C-4).

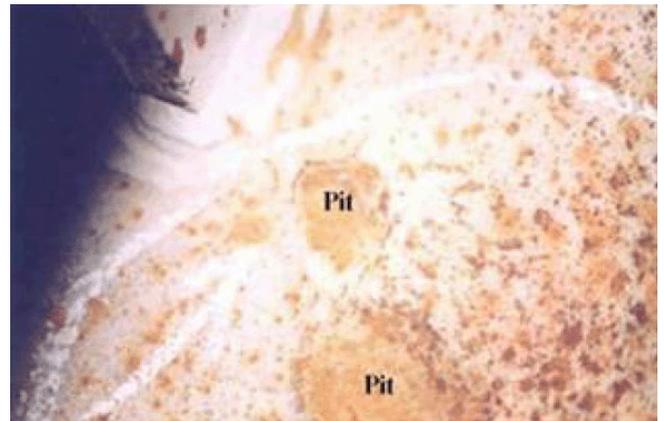
The pitting of the floor plate was observed mainly near the brine gate at different stages with maximum depth of 12 mm which has been caused by galvanic action between brine gate material (316l SS) and floor material (carbon steel). Figs. 3 and 4 show the pitting on the floor near the brine gate.

Fig. 3. Pitting corrosion in the floor of flash chamber.

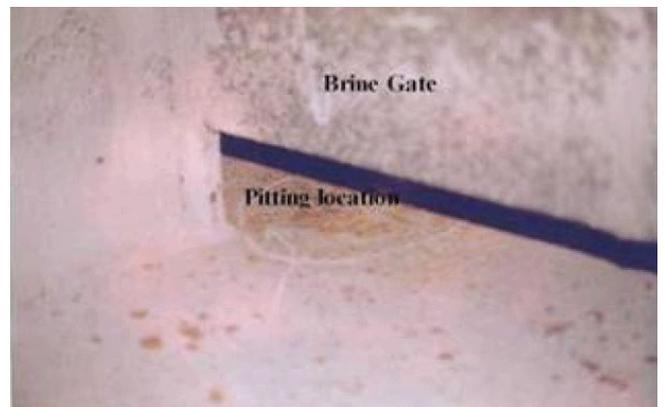
Fig. 4. Pitting on carbon steel desalination floor near the brine gate manufactured from 316 SS.

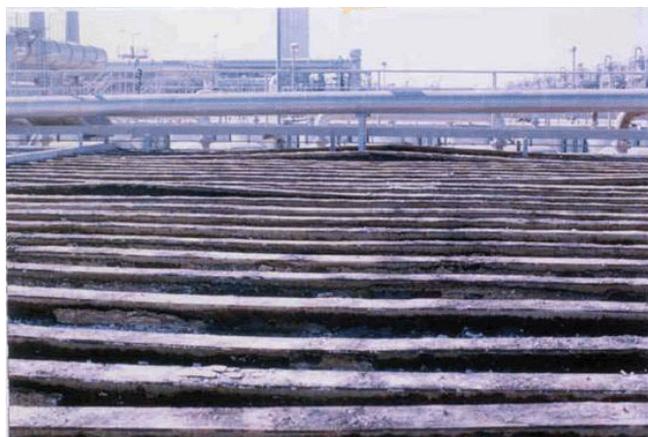
During the inspection of the flash chamber external roof surface, severe corrosion was found in this area (all ten units) (Fig. 5). Two across beams are installed in stages #5 and #15 and the corrosion was found concentrated in this area. All the T-beams were found badly corroded with localized thinning on the roof plate. The main reason of

this corrosion is the poor ventilation and stoppage of water in that area.

Fig. 5. Photograph showing severe corrosion of stiffeners and roll plates in Area C-5

humidity in the atmosphere, any water on the top of the aluminum sheet would penetrate through the sheet and likely corrode the underneath metal as a result of the corrosive nature of seawater. To avoid roof corrosion problems, three points should be considered: (1) good ventilation in order to minimize wetness time, (2) application of a good quality epoxy coating considering the lifetime of the coating and (3) periodic inspection of coating and roof material.

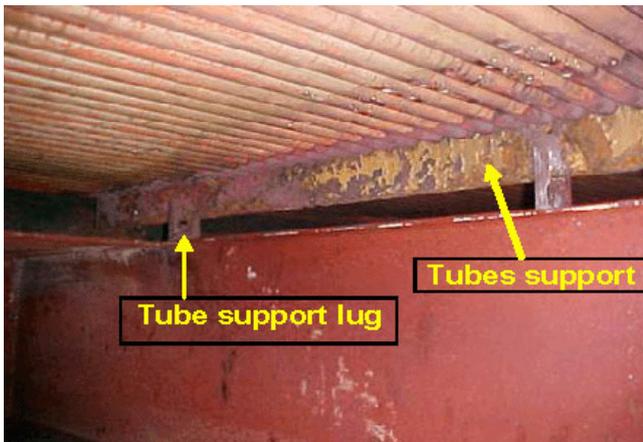
The lower section of the tubes support was connected to the product water tray which was fabricated from 316 L; therefore, the galvanic corrosion occurred. Almost 35% of the original thickness was lost due to corrosion. The main factors controlling the galvanic action in this location are: (1) pH, (2) conductivity of product water and (3) oxygen content.

Figs. 6 and 7 show the severity of corrosion on the lower part and lug of tubes support.

Fig. 6. Corrosion of lower section of tube support and lugs.

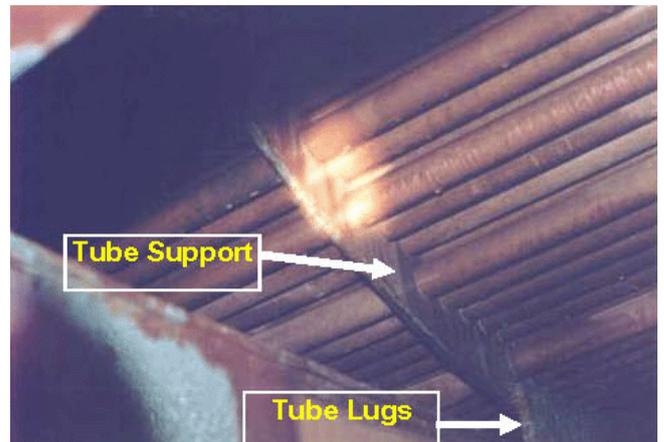
The second problem facing tube support is the tube opening. The carbon steel tube support was in contact with the tube material made from 90/10 Cu/Ni. Due to the difference in corrosion potential between these materials, the galvanic action was actuated. The main factor controlling the galvanic action in this location was non-condensable gases, which affected the pH of condensing water over the tubes.

Fig. 7. Corrosion of tube support lugs.

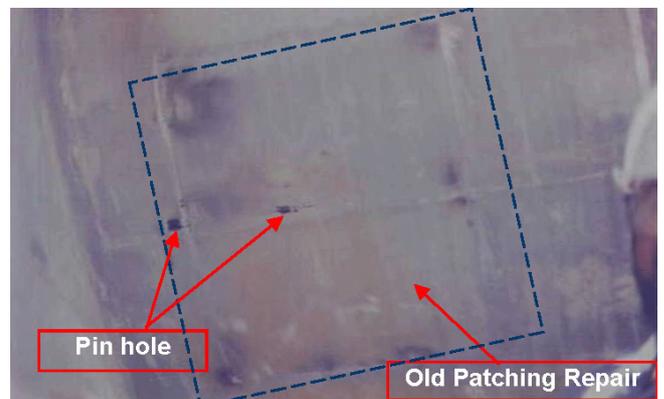
observed in C-4 area due to design problems. Fig. 9 shows the presence of pinholes in this area.

The pitting and general corrosion were observed in this area with full through wall pitting penetration in some areas. The tube length was longer than the width of flash chamber, so as to increase the heat transfer area. Therefore, the flash chamber was extended in the tubes bundle area only which will result in a layer of low pH water which will always be present in the condenser collar. Also, the water level in this area could cover the first row of the tubes. With the presence of non-condensable gases which could be dissolved in this layer, the pH will be decreased, and also the galvanic action between the carbon steel support and 90/10 Cu/Ni and

Fig. 9. Corrosion in condenser collar of one flash chamber.

tubes would play a main role in the corrosion process. This problem can be resolved by modifying the design stage, this can be done by decreasing the length of tubes.

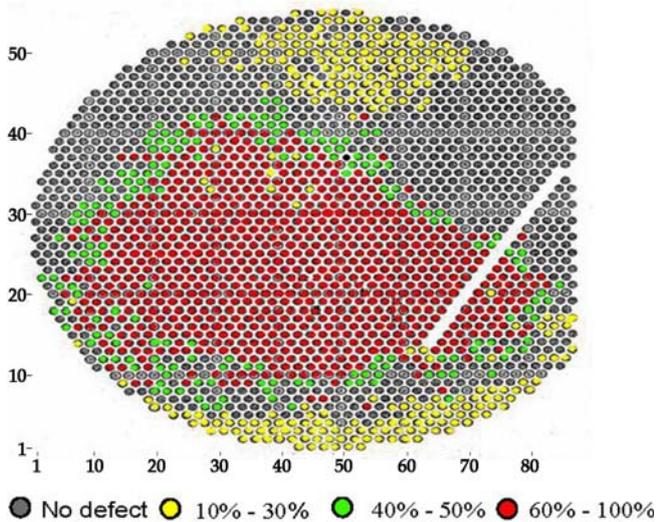
Fig. 10. Results of eddy current studies of the first stage condenser.

After approximately 14 years of evaporator operations, a sudden appearance of large numbers of 90/10 Cu/Ni tube failure in the first stage was noted. Fig. 10 shows the result of eddy current testing. The results of eddy current can be summarized as followed:

- The defective tubes are concentrated at the center of the lower half of the tube bundle.
- The corrosion started on the external surface (vapor side).
- Most of the defects are concentrated at the tube end closer to the tubes sheet.
- All units in C-4 area show same severity of corrosion.
- Metal losses from the external surface have also been noticed on some of the tubes at the tube support points.
- The severity of corrosion in the tube is higher at one end compared to other end.
- The rotary scan by eddy current is required and important with long tube testing in order to evaluate the condenser tubes condition.

It was found that tube failure is due to crevice corrosion, which is accelerated by the following conditions [3]:

- Galvanic action between 316 SS and 90/10 Cu/Ni.
- Low pH due to the accumulation of CO₂.
- Vibration of tube due to the gap created between tube and tube support.

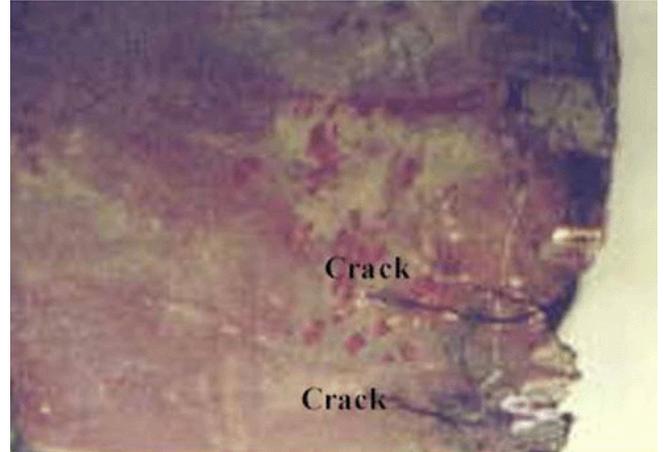
Fig. 11. Outside surface of vent line.

The vent piping system is made from stainless steel 316 for high-temperature stages and FRP for low-temperature stages. The visual inspection of inner and outer surfaces shows many cracks and pipe thinning. The cracks are initiated from a thinner area with many branches from the inner surface. All the cracks are found near the weld joints. Figs. 11 and 12 show the extent of damage on vent line pipe. The corrosion in the pipe can be attributed to the low pH.

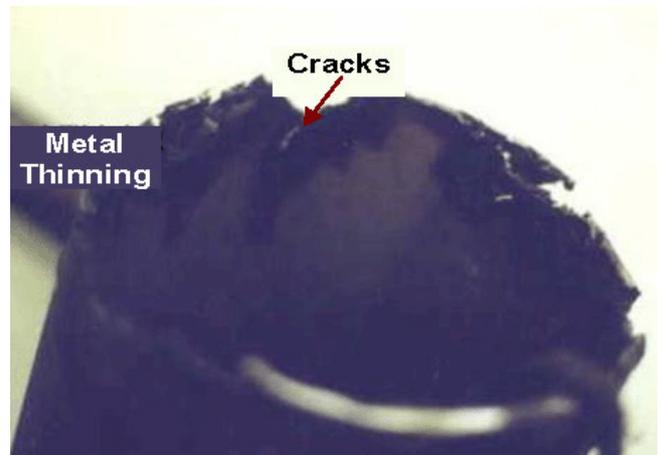
Fig. 12. Inner surface of vent line.
