Corrosion failure 90/10 cupronickel tubes in a desalination plant

This paper presents finding of a failure investigation on a heat exchanger tubes in a desalination plant. Fabricated from Type 90-10 copper–nickel alloy, the tubes experienced sever corrosion after one year of operation. Leaks were observed due to pitting attack requiring repairs and eventual replacement of the cupronickel tubes. The cause of the failure was determined by conducting a physical inspection, and performing macro and micro examinations. The failure of the tubes was mainly attributed to the high iron content (up to 6%). The results of the failure investigation are discussed along with corrosion issues that were identified in the associated heat exchanger tubes.

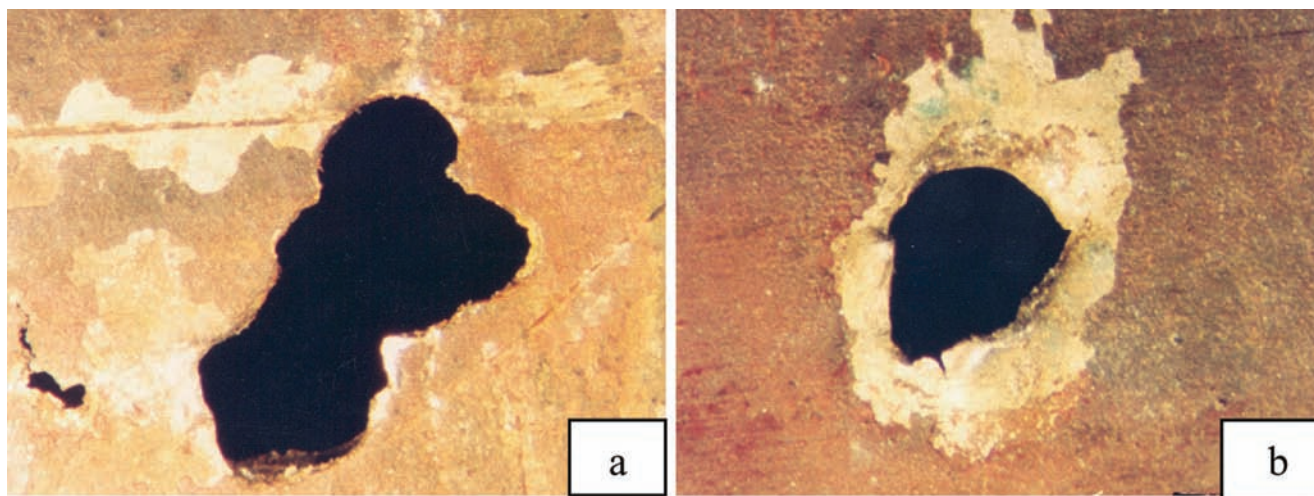
Fig. 2. Isolated pits of different morphology and sizes (on the inner surface of the failed tubes).

size pits to irregular with increased pit size (Figure 2a and b). The extent of the corrosion pits can be observed on the external tube surface. The samples developed discontinuous layers of thick, non-adherent, brown, greenish-brown corrosion product films interspersed with blackish deposits around some attacked area.

In the direction of seawater flow a kind of striation are found. Pitting attack was more pronounced closer to the flow marks (Figure 2a) indicating the role of fluid flow on the pitting process.

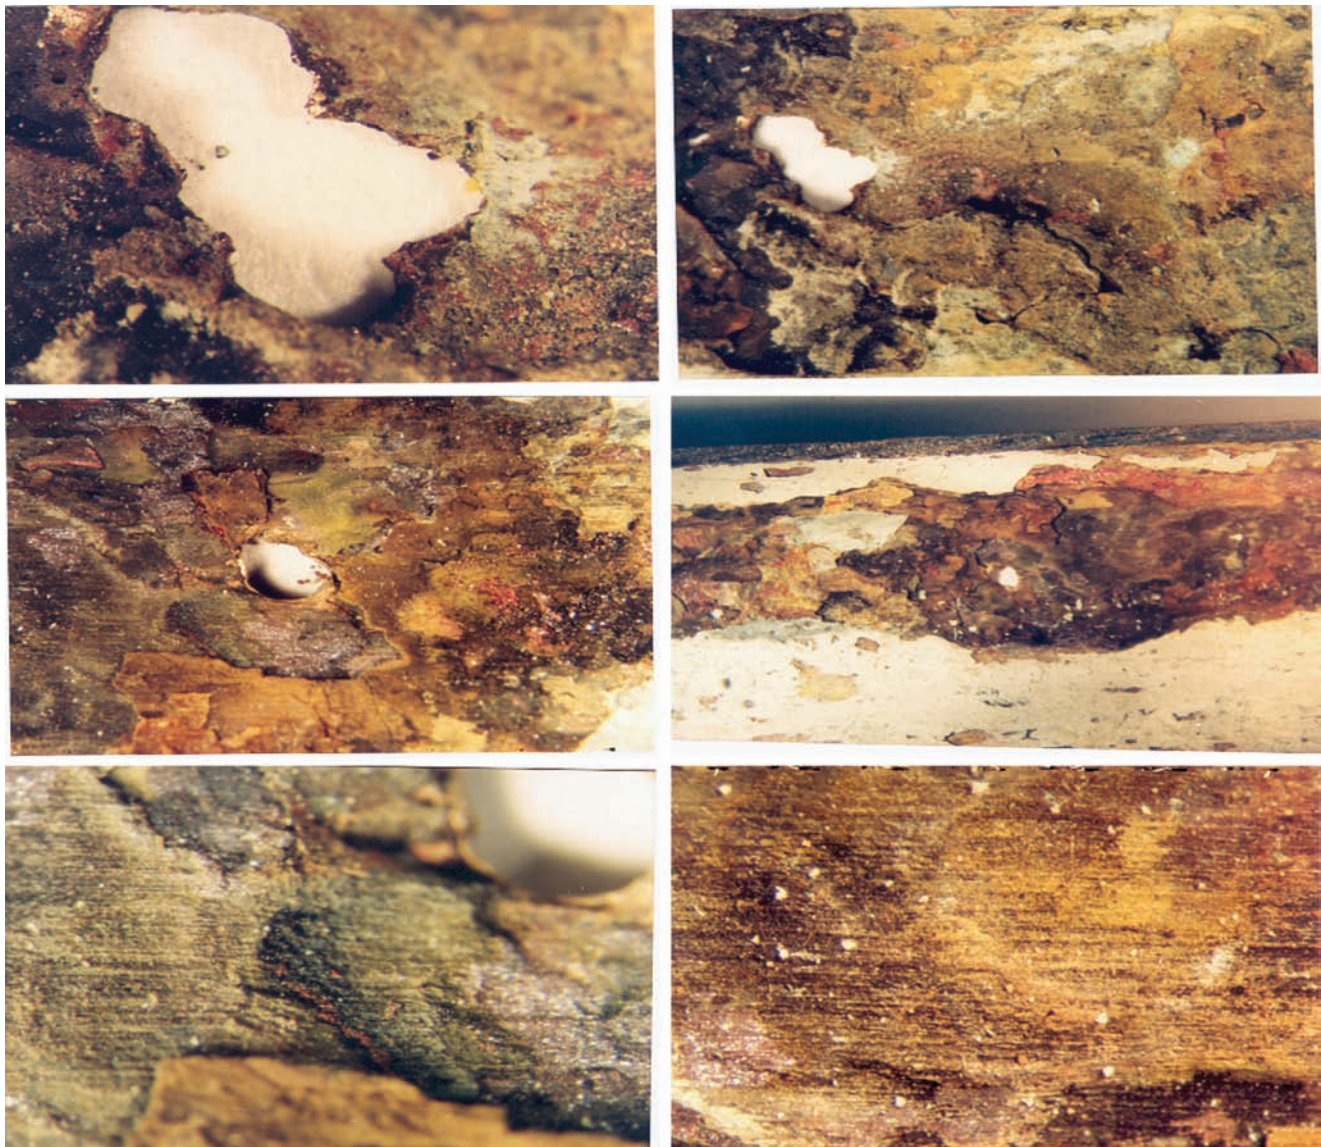
Results of the microscopic examination (low magnification up to 40X) on the inner part of the tubes are given in Figure 3. Flow groves as a result of high velocity within the tubes were observable around and remote from the corrosion pits. Thick non-adherent corrosion products and scaled deposits of different colors (green, black and brown or mixed) formed around the impingement area were visible. Isolated pits covered with corrosion product appears to form at the flow groves area. The extent of the corrosion damage can be seen from the deep pits that penetrating throughout the pipe wall thickness.

Fig. 3. Microscopic photograph of the inner part of the failed cupronickel condenser tubes (up to 40X).

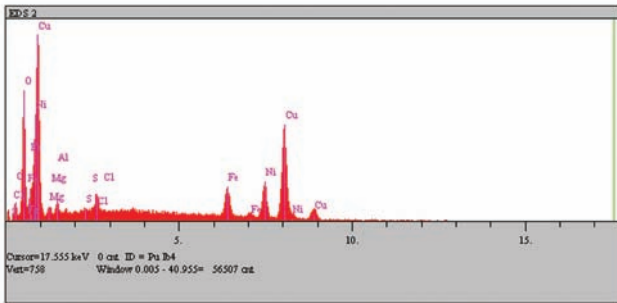
SEM-EDAX was utilized to analyze the chemical composition of the received metal tubes. The results are given in Figure 4. The results revealed that the tubes were made of Cu–Ni most properly 90/10 type. EDAX results showed relatively low Cu content which can be attributed to the fact that Cu usually identified as Cu_2O on the tube surface exposed to air prior to analysis [11].

The most interesting result was the detection of higher iron (Fe) content (up to 6 wt%). This was also confirmed by the ferrite-scope meter. High amount of iron (range of 3–6 wt%), was detected within the examined Cu–Ni tubes.

Figure 4 also showed higher carbon content. This may be attributed to the build-up of scale (carbonate- HCO_3) as a result of CO_2 gas present within the system (dissolved within the water droplet), particularly when the vacuum system working inefficiently [3,4].

In the current case, high iron (Fe) content (well above the design range) was detected both by ferrites-scope meter and SEM-EDAX analysis as shown

Fig. 4. EDX picture and composition of the failed condenser cupronickel tube.

in the attached tables. The presence of excess iron in the 90Cu–10 Ni causes the formation of iron-rich phase in the grain-boundary network. This, in turn, promotes corrosion of the grain boundary material due to galvanic coupling, leading to localized attack [9].

In the current case the failure of the tubes is probably related to the higher iron content. Corrosion of heat-exchanger tubes seem to be first initiated at heavy iron containing precipitates and the corrosion process is aggravated by the seawater flow. Higher seawater velocity are expected to cause vortices leading to impingement attack which aggravates premature failure.

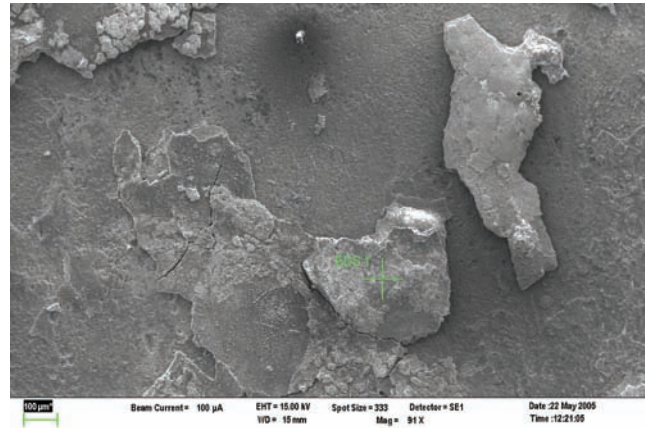
The results presented in Figure 6 confirm the involvement of Cu, Ni, Fe, S and Cl in the corrosion deposits. This seems to indicate that the corrosion product deposits consist mainly of cuprous/cupric oxides and iron oxide. The presence of relatively higher sulfur content suggests the involvement of copper sulfide in the corrosion process.

Fig. 6. High magnification image obtained by SEM and EDX composition of the corrosion product formed on the inner part of the failed cupronickel condenser.

The development of black friable deposits around the attacked areas along with the presence of small deep pits small and the detection of relatively higher sulfur content in the corrosion product as analyzed by EDX suggests the involvement microbial corrosion activity in the pitting corrosion process. However, the use of chlorination system and the results of the microbiological analysis on black deposits excluded this role. The presence of metal sulfide is probably related to the contamination of seawater with sulfide species. The presence of such species aggravates the pitting corrosion process and hinders alloy passivity. Seawater sample analysis was not provided to verify this point.

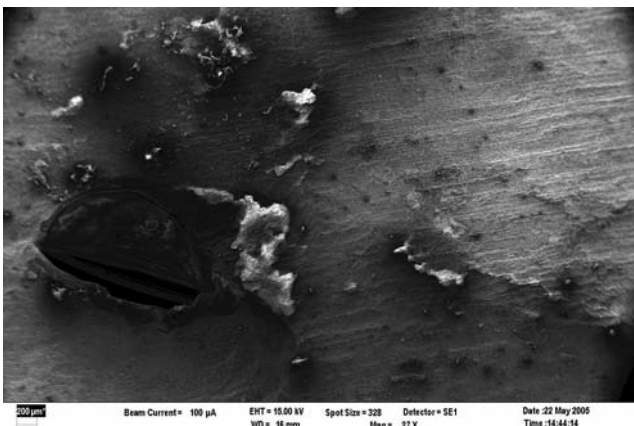
As can be seen in Figure 5, parallel grooves around the perforated hole (pit throughout the wall thickness) as a results turbulence flow were evident.

Fig. 5. High magnification image obtained by SEM for the inner part of the failed cupronickel condenser.
