Corrosion of heat exchanger in thermal desalination plants and current trends in material selection

Anees U. Malik*, Saleh A. Al-Fozan, Fahd Al-Muaili

Saline Water Desalination Research Institute (SWDRI), Saline Water Conversion Corporation (SWCC), P.O. Box 8328, Al-Jubail 31951, Saudi Arabia; email: rdc@swcc.gov.sa (A.U. Malik)

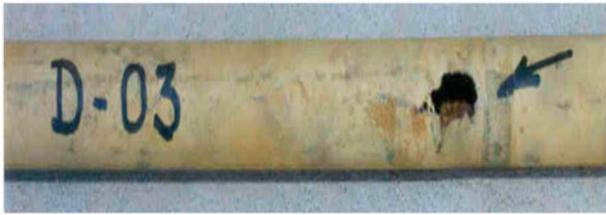
The desal D-03 tube was located on top rows below the distribution tray. This tube had a perforation of 18 × 10 mm size at the center along with many perforations of smaller sizes (Fig. 2). The maximum allowable velocity of liquid impingement on Al–brass material (desal tube) is around 2 m/s. These tubes are susceptible to impingement corrosion when the velocity exceeds the said limit in the plant. The impingement condition is particularly severe when they are in the

Fig. 2. Close up view of failed portion of evaporator tubes D-03 showing few surface depression marks.

top zone of two rows of the evaporator chamber. The D-03 tube was in fact below the spray distribution trays of the evaporator chamber and one, therefore, expects the impingement occurring by the flowing seawater.

- (1) Failure of the tube is due to impingement attack of seawater on the tube surface.

- (2) Perforation of tubes is due to material wastage by pitting preceded by liquid impingement.

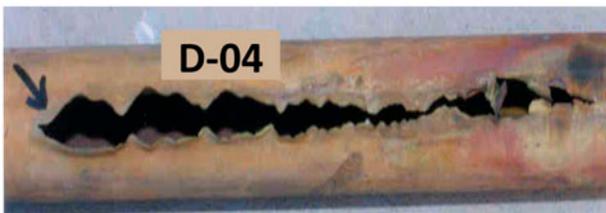
The D-04 tube was ruptured at one end with rupture length of approx. 360 mm (Fig. 3). In case of D-04 tube, the failed area of the tube was facing the bottom of the evaporator. The inspection of the rupture area indicates that the material (Al-brass) wastage at the failure area had led to the failure of tube. Rupture edges are thin and ragged because of the wasted brass. The wastage brass appears to be the effect of erosion-corrosion.

Fig. 3. Tube D-04 showing rupture edges due to erosive thinning.

- (1) The failure of the tube most likely due to erosion-corrosion.
- (2) The erosive thinning of material had led to rupture of the tube.

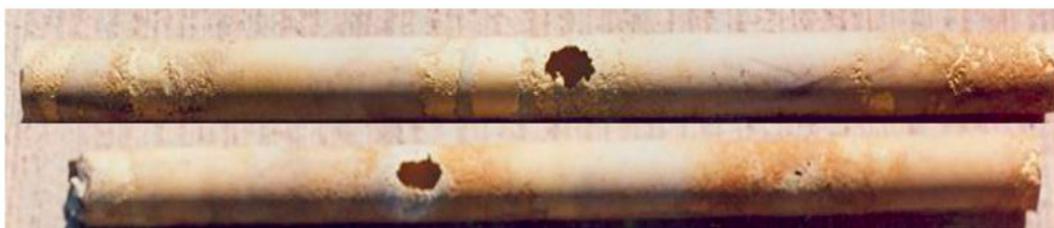
The failed tubes of desal units were located at the first and second row of the tube bundle of the 2nd effect chamber. In all, 31 numbers of tubes have failed during service. The tubes were located just below the seawater distribution trays and were in service since 13 years.

The tubes were inspected physically on receipt. The tubes were of size 19 mm OD \times 1.0 mm thickness. The outer surface of the tubes contained patches of visibly thick scales and pits. Both the tubes surface contained small and big size (approximately 15 mm dia) holes (Fig. 4). The big size holes are characterized by undercut grooves with directional pattern moving away from the center of the holes. Substantial thinning of the metal near the edges of the holes is seen indicating erosion-corrosion of the metal occurred from the top surface during the service. Plenty of surface pits are also noticed on the tubes. The inner portion of tube surface contained uniform layer of greenish colored scale deposits and were free from pitting.

Fig. 4. Photograph of leaked tubes in as received condition.

The deposits were found to be consisted of S, Cl, Mg, Ca, and O₂ indicating the presence of sulfides, chlorides, and oxides. The inner surface scales deposits were mainly consisted of copper-oxide. The outer scale deposits were non-uniform in thickness and discontinuous in nature whereas the inner scales were uniformly thick. The gradual thinning and subsequent perforation of the tubes led to believe that this is the case of attack on metal from the outer surface agent during service.

- (1) The failure of tubes is most likely due to erosion-corrosion.
- (2) Non-uniform spray distribution pattern of seawater on the tubes was responsible for the observed localized perforation of tubes.
- (3) Development of non-adherent protective oxide film during service might have also been responsible for the premature failure of the tubes.

It was recommended that (i) during plant maintenance, thorough cleaning of seawater distribution trays, holes/nozzles of the trays and ensuring uniform spray pattern on the tubes during operation would help in limiting the erosion-corrosion, and (ii) use of better condenser tube material such as 90Cu/10Ni could avoid early failure of the desal tubes.

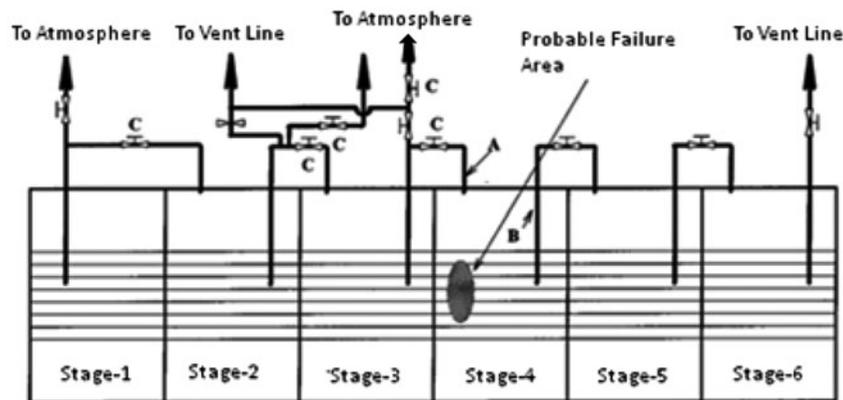
Fig. 5. Vent line in unit 16, module 1 of Jeddah IV desalination plant.

- (3) Stage 4 is connected, through pipe A to a direct vent line and an opening to the atmosphere as well. However, the pipe A is closed and the opening of this pipe in the evaporator is near the roof. The venting stages 4 and 5 evaporator is done through the other pipe B which is connected to the vent extraction tray. Through the pipe-B, NC gases are cascaded to the stage 6 where it is finally joins the vent line.

- (4) The major fault of the design of the evaporator of stage 4 was the absence of any direct connection with the vent line. It seems that due to poor venting of this corrosive gases evolved, enter into pipe A were trapped and get condensed. The condensate will be acidic in nature due to dissolution of CO₂ and other corrosive gases, e.g. H₂S, Cl₂, SO₂, etc. The condensate drops on the 2 sides causing general corrosion of the tubes. It also corrodes the nearest partition wall of stages 3 and 4.

The failure of condenser tubes in stage 4 (cascade between 3 and 4) is due to the dropping of the acid condensate from closed vent pipe A resulting in the corrosion of tubes.

Stage 4 should be directly connected to the vent line either by opening the valve of the vent line A or by some appropriate design modification.

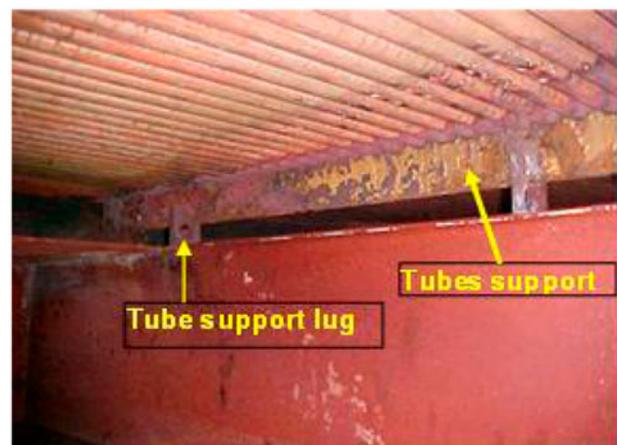
The tube supports are fabricated from 316L in first two stages and from carbon steel for the other stages. The stainless steel supports were in good condition but the carbon steel supports were found corroded. The corrosion was observed at two locations: at the bottom which is welded to product water tray and at the tube opening. The mechanism of corrosion in both locations appeared to be galvanic (Fig. 6).

The lower section of the tubes support was connected to the product water tray which was fabricated from 3,16L, therefore, the galvanic corrosion had occurred. Almost 35% of the original thickness was lost due to corrosion. The main factors controlling the galvanic action in this location are: (i) pH, (ii) conductivity of product water, and (iii) oxygen content.

Fig. 6. Corrosion of lower section of tubes support and lugs.

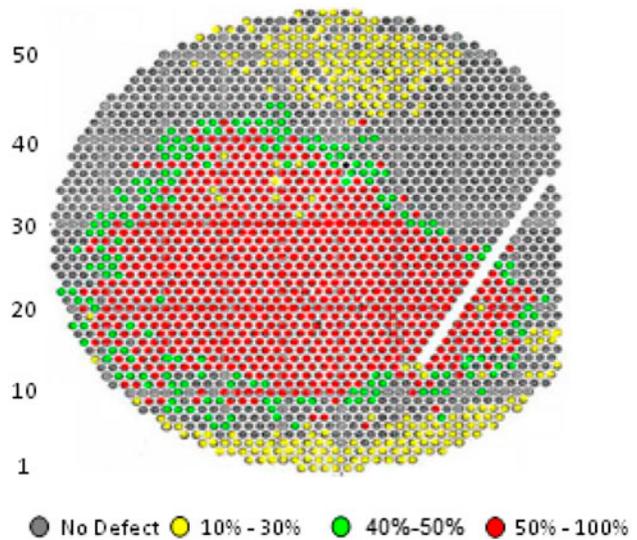
- (1) The defective tubes are concentrated at the center of the lower half of the tube bundle.
- (2) The corrosion started on the external surface (vapor side).
- (3) Most of the defects are concentrated at the tube end closer to the tubes sheet.
- (4) Metal losses from the external surface have also been noticed on some of the tubes at the tube support points.
- (5) The severity of corrosion in the tube is higher at one end compared to other end.

Fig. 7. Results of eddy current studies of first stage condenser.

It was concluded the tube failure is related to crevice corrosion which is accelerated under the following conditions prevailing around the tube bundle: (i) galvanic corrosion between 316 SS and 90/10 Cu–Ni, (ii) Low pH due to accumulation of CO₂, and (iii) vibration of tube due to the gap created between tube and tube support.

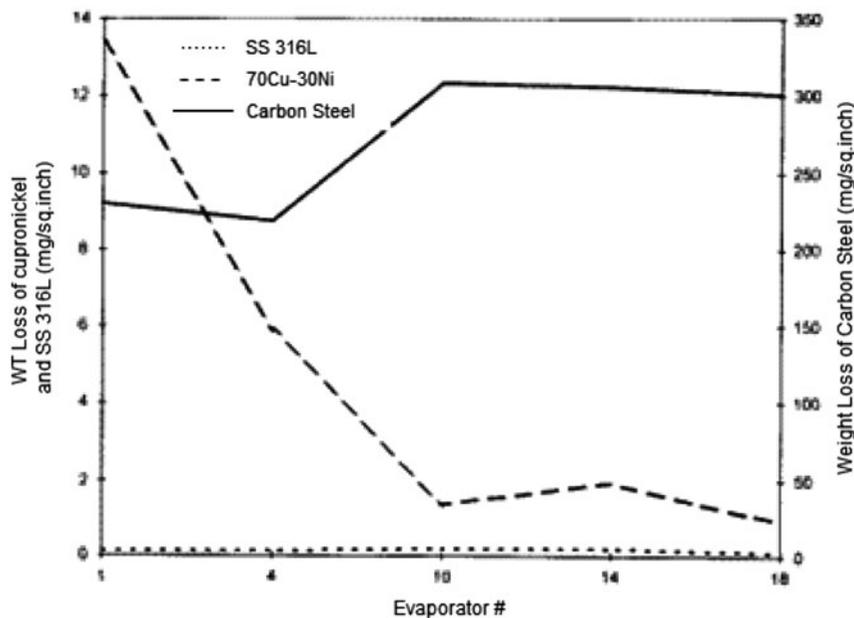
Fig. 8. VSC of different materials exposed for 9,000 h in flash chambers of MSF desalination plant. (Plots showing weight losses in different materials at different stages of evaporator.)
