## Minimizing environmental risks on constructing marine pipelines: Águilas desalination plant

In the building of marine brine discharge pipelines from desalination plants, there are some technical and environmental conditions that require previous numerous studies to guarantee their viability. In the project of Águilas desalination plant with a production capacity of 180.000 m<sup>3</sup>/day, in Murcia, Spain, a marine emissary was designed. It was made up of various sections that entail different building complexities. The main difficulty was to build a tunnel in the rocky massif called “Peñon del Roncaor”; the tunnel was dug through a piling of 443 m of length and an exterior diameter of 2.400 mm that would have come up at a depth of 12 m to join the submarine section of 290 m of length. These more detailed geotechnical studies showed a great heterogeneity in the composition of the materials to be excavated from the Peñon. In order to avoid any risk of affecting to the castle right above considered of cultural interest, a new tracing of the tunnel was designed. The new tracing runs the Peñon’s outer south borders right into the dumping area. This new tracing implies greater le

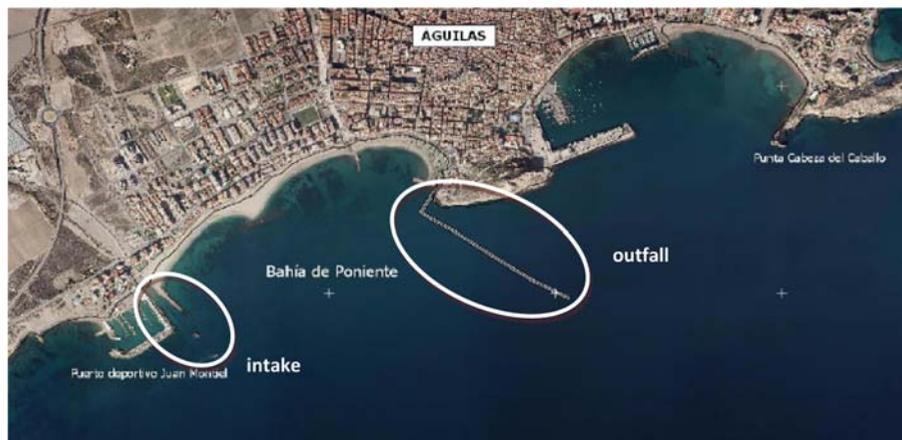
Fig. 1. Intake and outfall construction zones.

The open intake is situated in the south of the emissary, in the mouth of the dry riverbed named Cañerete (Fig. 1). It was mainly built between April and September 2009. The complementary works to end the construction took place at the end of 2011.

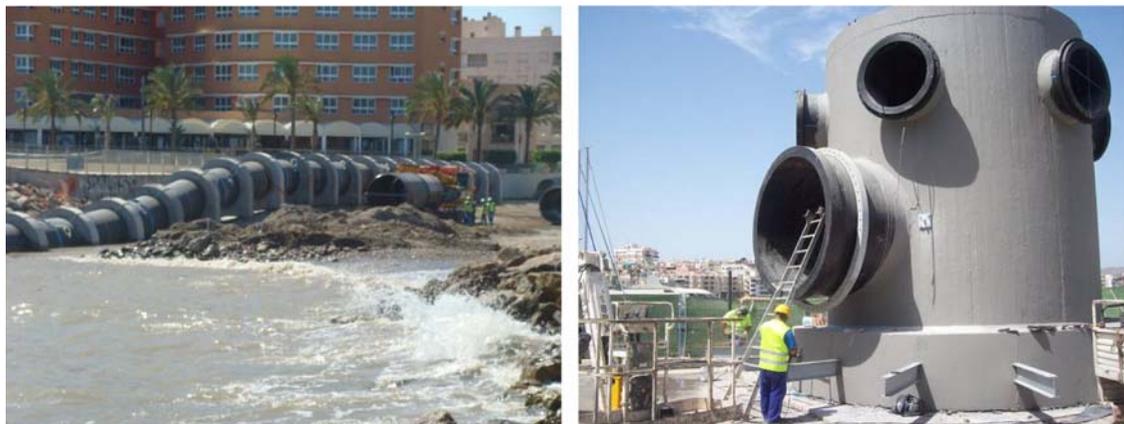
Fig. 2. Launching ramp and water tower intake.

The part of the open intake closest to land was carried out by a 320 m stake with an access shaft located in the riverbed on the left side simply following the alignment of the dry riverbed stretch. The building procedure involved drilling a tunnel which minimizes the surface occupation that, otherwise, would have required digging a trench of more than 9 m deep in an urban area. Due to space limitations at the mouth of the dry riverbed Cañerete, the pipes were directly placed over a launching ramp when they were being welded. (Fig. 2)

The design of the intake tower (Fig. 2) that sits on the seafloor at a depth of 18 m secures horizontal currents of low velocity and a laminar flow, so the dragging of marine organisms is minimized in it, as well as the suspension of solids in stormy weather and dragging of thick particles too.

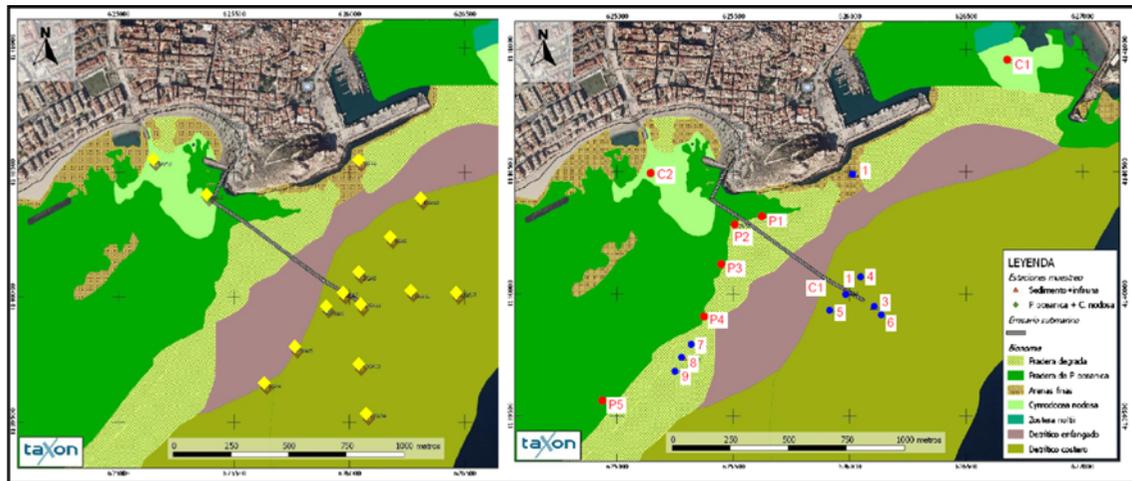
Fig. 3. Previous control point of the works for the water quality control (yellow), sediments and benthonic communities (blue) and *Posidonia oceanica* (P), and *Cymodocea nodosa* (C) meadows. P5 is a control station.

(b) Related to the water quality in the surrounding area of the dumping, there is information from August 2008. There are 15 sampling stations (Fig. 3) distributed as follows: three along the costal area, one in the dumping area of the effluent, three in a radius of 100 m around the dumping area, four in a radius of 300 m, and others in a radius of 500 m.

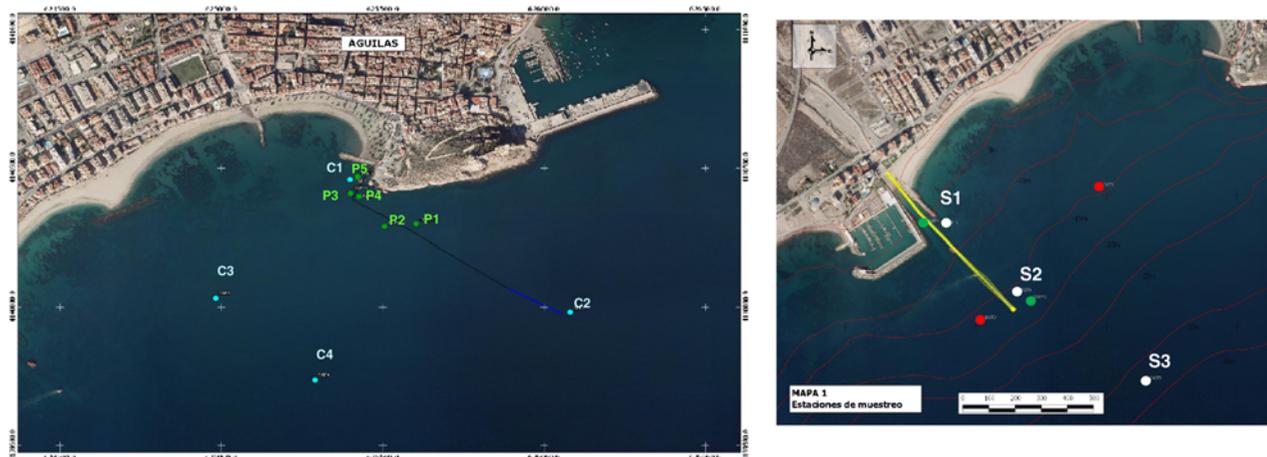
Fig. 4. Water quality control station, sediments, and benthonic communities (C) *P. oceanica* seabeds (P) left: outfall, during and after works; Right: open intake, before-during and after works (white spots for water quality; red spots for sediments and infauna; green spots for seagrass meadows).

During the execution works (Fig. 4), four sampling stations were established around the dumping area (C1–C4), two of them close to the works—C1 (at 4 m deep and above *P. oceanica*) and C2 (at 32 m deep on a coastal detritic seabed). Two of them are sufficiently far away from the works acting as a control station. C3 (at 10 m deep on *P. oceanica*) and C4 (at 26 m deep on a coastal detritic seabed). The campaigns were carried out between November 2010 and August 2011 during which records related to turbidity and suspended solids were taken.

During the work of the intake, the control stations are set around the influence area Fig. 4. The control of the seagrass *P. oceanica* community is done by direct observation of the area that surrounds the pipeline. The surface of the prairie affected by excavation, burial sediment process, and lack of light is studied. The same previous parameters are measured.

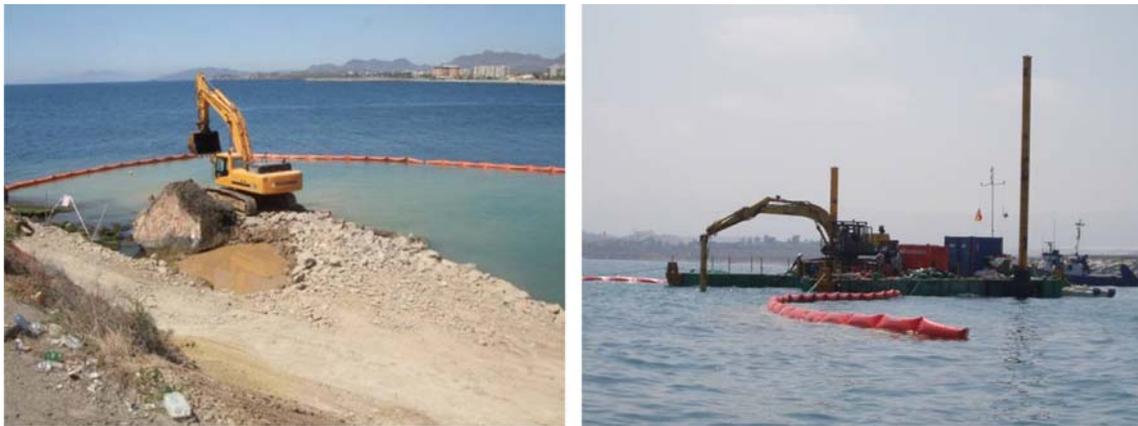
Fig. 8. Turbidity curtain surrounding the dike and barrier construction (left) and the marine excavation works (right).

The turbidity barriers have successfully remained on site throughout the entire time of the excavation works (Fig. 8) when enclosures were created. However, when these barriers were placed in open sea their effectiveness was reduced as proven in the execution of the intake. Likewise, bad marine weather conditions have displaced barriers or ground them breaking floating devices and curtains; it was necessary to replace them.

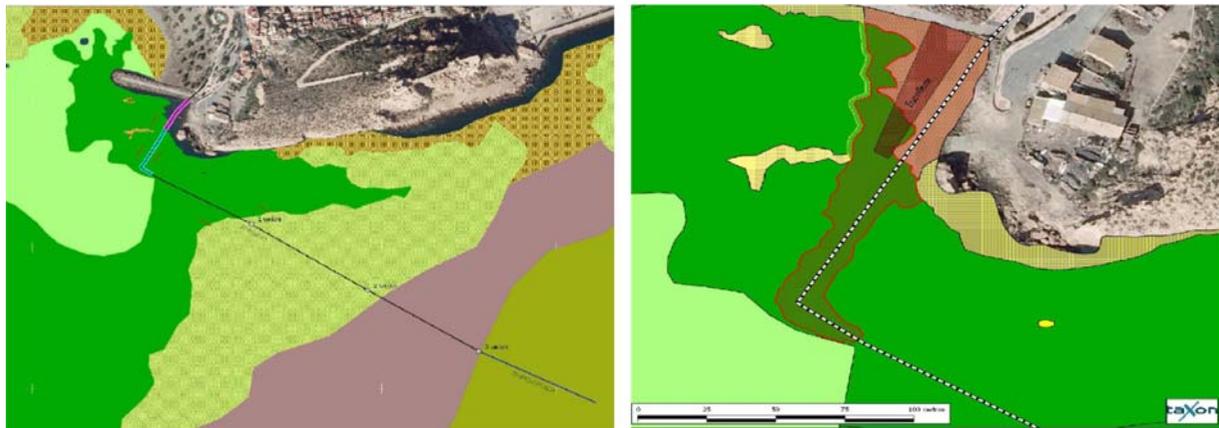
Fig. 11. Surface affected by the outfall works. Left: ditch excavation area (purple), Jetty (blue). Right: surface of *Posidonia oceanica* directly affected by the works (red) and semi buried prairie (green stretch parallel to the jetty).

At the works of the outfall, the greatest harm on the *P. oceanica* meadow has been produced by the construction and dismantling of the jetty used as a work platform for the excavation of the ditch, where the emissary is placed and also because of the burial of the prairie in the construction of the jetty that sets the piping to the bottom (Fig. 11). So, the harmed area of the prairie has been around 2.357 m<sup>2</sup>; we must add the surface occupied by the ballasts of the emissary to the first flange union that practically coincides with the ending of *P. oceanica*. Out this surface, 65.66 m<sup>2</sup> corresponds to the excavated area and the rest, 2.291 m<sup>2</sup> to the jetty area.
