MSF evaporator materials evaluation after 20 years in service

Saleh A. Al-Fozan*, Anees U. Malik

Saline Water Desalination Research Institute, Saline Water Conversion Cooperation, PO Box # 8328, Al-Jubail 31951, Kingdom of Saudi Arabia

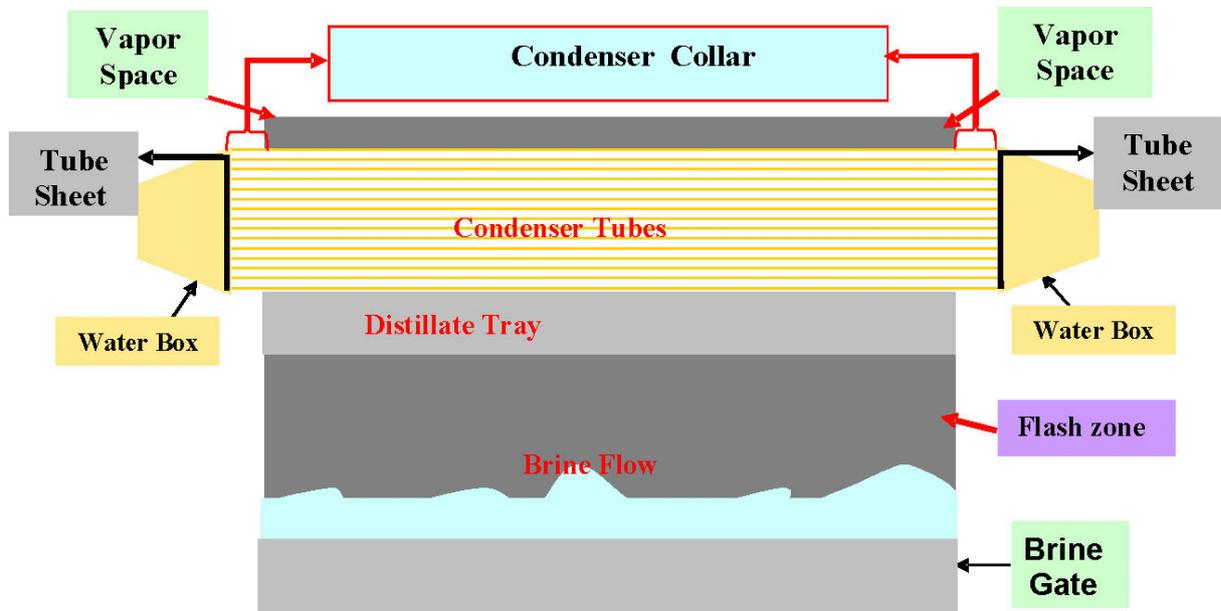
Fig. 8 shows a schematic of condenser collar in a flash chamber. The corrosion of the condenser collar was

Fig. 8. Schematic of condenser collar in a flash chamber.

observed in C-4 area due to design problems. Fig. 9 shows the presence of pinholes in this area.
