# Evaluating the effect of periodic disinfectant type transitions on the corrosion rate of common distribution system metals

# Angela B. Rodriguez, Steven J. Duranceau\*

### ABSTRACT

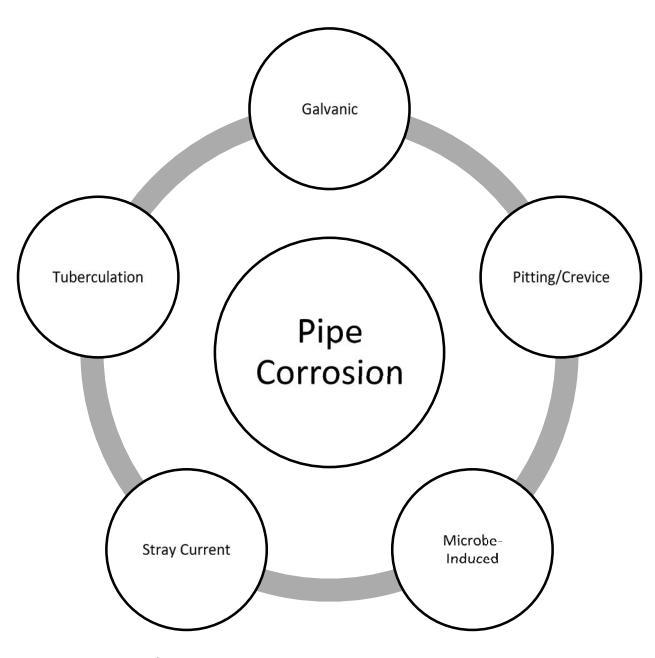
Fig. 1. Types of corrosion.

There are many different types of corrosion, each of which is categorized by the cause of the metal's deterioration (Fig. 1) [1]. In most potable water systems, corrosion can typically be found near dissimilar metal joints, anaerobic/aerobic zones developed by particulate deposition or microbial growth, and sections of pipe that are used for electrical grounding purposes [2]. When corrosion is left unchecked, utilities can experience a wide range of complaints including: (1) stains on clothes and fixtures, (2) taste and odor issues, (3) pressure loss and hot water problems, and (4) elevated heavy metal content in tap water.

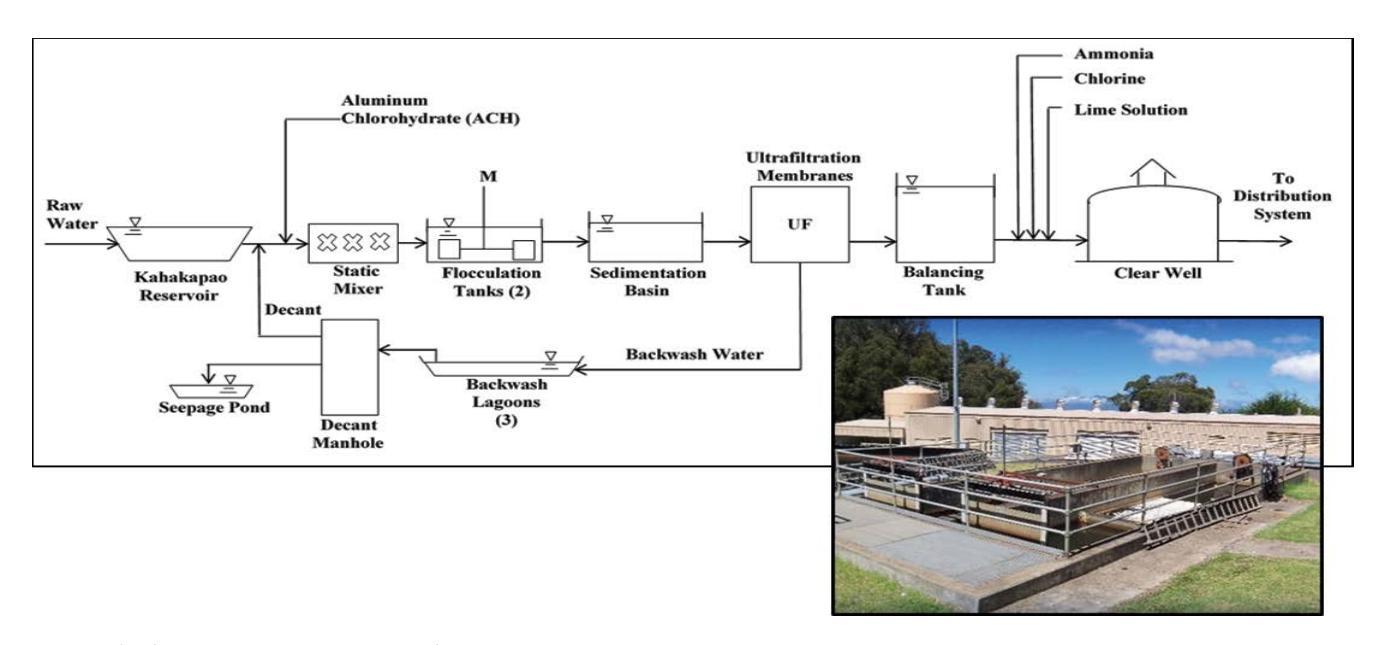
Fig. 3. Olinda WTP treatment process schematic.

capacity facility which sits at an elevation of 4,130 ft. The Olinda WTP treatment process, shown in Fig. 3, utilizes conventional treatment followed by ultrafiltration membranes to treat the surface water before disinfection and pH adjusting. Due to the water's high disinfection byproduct (DBP) potential, the disinfection process is carried out by adding ammonia ahead of chlorine. Corrosion control for the Upper Kula system consists of pH adjusting to 8.8 pH units utilizing slaked lime.

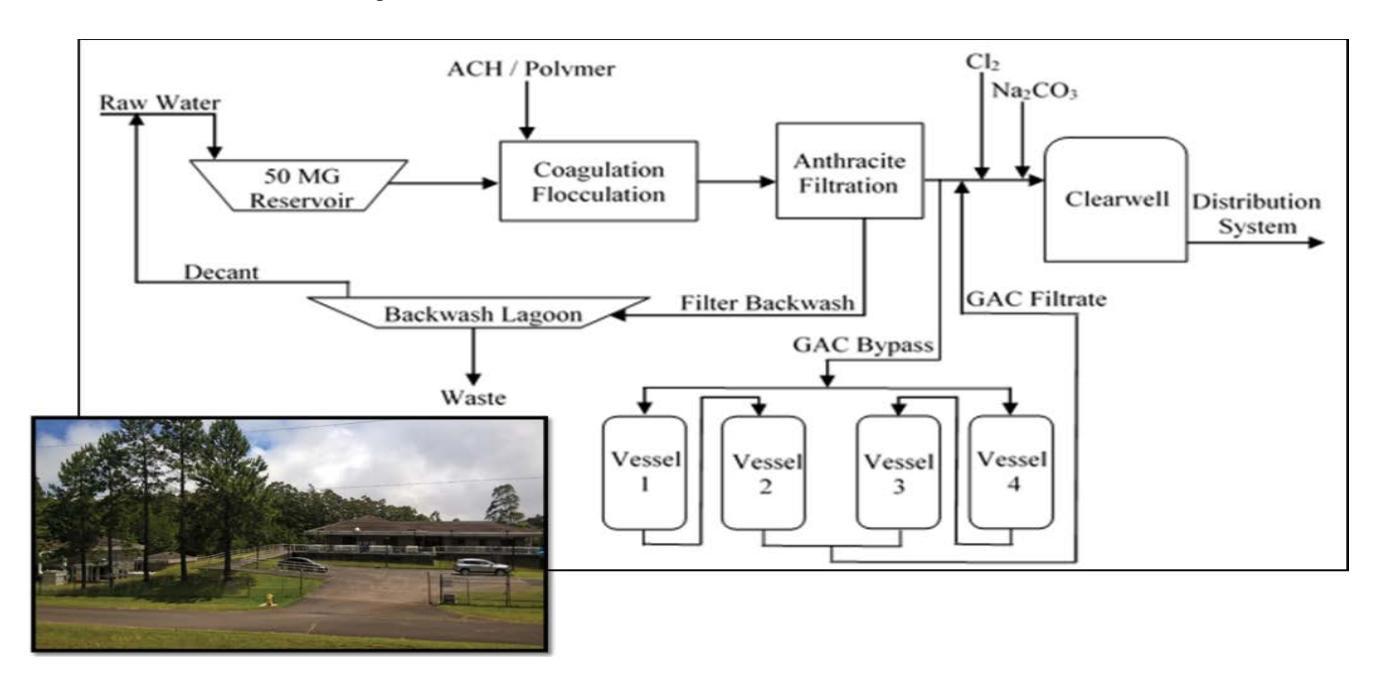
Fig. 4. Pi'iholo WTP treatment process schematic.

The Pi'iholo forest surface water supply typically has a pH of approximately 6.8 pH units, a true color range between 15 and 25 color units, and approximately 8.5 mg/L as CaCO<sub>2</sub> of alkalinity. The water is treated by the Pi'iholo WTP, an 8.0 MGD capacity facility which sits at an elevation of 2,860 ft. The Pi'iholo WTP treatment process, shown in Fig. 4, utilizes coagulation, direct dual-media filtration, and granular activated carbon (GAC) prior to disinfection and pH adjustment. In comparison with the Olinda WTP, the water at the Pi'iholo WTP is disinfected with chlorine and pH adjusted to 8.8 pH units with soda ash for corrosion control purposes before entering the Lower Kula system.

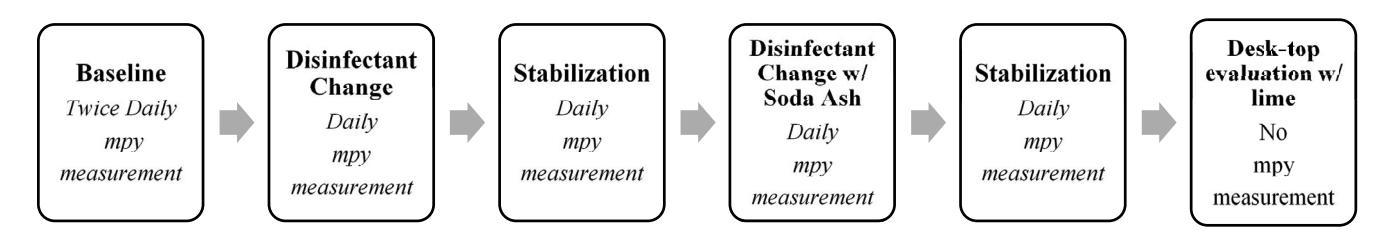
Fig. 5. Corrosion study phases.

Two corrosion racks were built to determine the effect on corrosion rates if Pi'iholo water was switched to chloramines from chlorine and if Olinda water was switched to chlorine from chloramines. The study was comprised of six general phases (Fig. 5) which included a baseline phase and stabilization phases in between experimental test conditions. The baseline phase, which is standard for UCF corrosions studies, aims at pre-corroding the metal coupons and probes prior to beginning the study to better simulate an aged distribution system. The stabilization phase in between experimental conditions were included to determine whether changes in corrosion rates when water quality changed were reversible or irreversible.

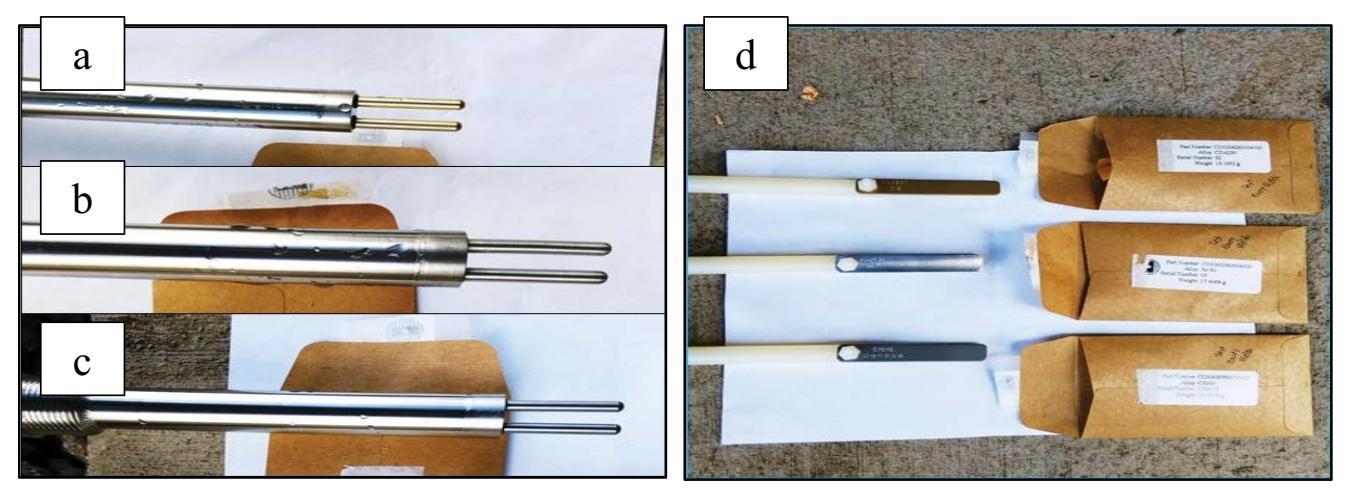
Fig. 6. Virgin metal probes (left) and coupons (right).

racks the rest of the time. The three metals investigated were mild steel (C1010) to simulate water mains, cartridge brass (CDA230) to simulate home copper pipes, and a 50:50 tin/lead (50/50 tin/lead) mix to simulate lead solder. Both metal probes for the electrochemical method and metal coupons for the gravimetric method were incorporated into the study corrosion racks. Pictures of virgin mild steel (a), cartridge brass (b), and 50:50 tin/lead (c) probes, and their respective coupons (d) can be seen in Fig. 6.

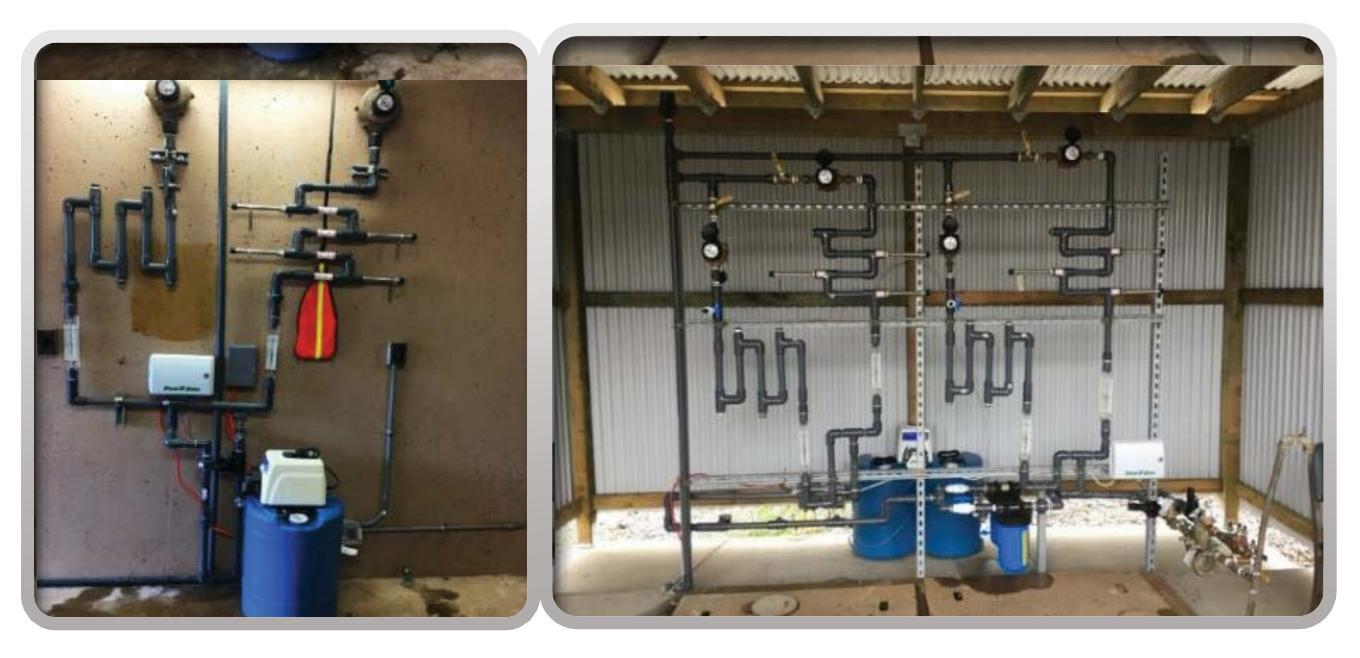
Fig. 7. Olinda (left) & Harry Fields (right) corrosion racks.

The Olinda WTP corrosion rack (Fig. 7) was located within the Olinda WTP and used to investigate the effect on corrosion rates if the Olinda finished water was switched from chloramines to chlorine. The Harry Fields corrosion rack (Fig. 7) was located in the Lower Kula distribution system and used to investigate the effect on corrosion rates if the Pi'iholo finished water was switched from chlorine to chloramines. Each corrosion rack was equipped with totalizers, flowmeters, and an automatic water flow on/off timer.

For the Olinda corrosion rack, one vertical PVC loop for the coupons and one horizontal PVC loop for the probes was installed along with the chemical feed system. At the Harry Fields corrosion rack, the Olinda corrosion rack set-up was duplicated to obtain a control and test side, with the test side being equipped with a chemical feed system. In addition, the Harry Fields corrosion rack's test side was equipped with a GAC system to remove free chlorine residual from the water. This was necessary to maintain proper ammonia to chlorine ratios when investigating the conversion from chlorine to chloramine as the residual at the distribution site was found to fluctuate daily by 1 mg/L. Due to site constraints, pH adjustment chemical corrosion rate impacts were determined using the computer modeling software.

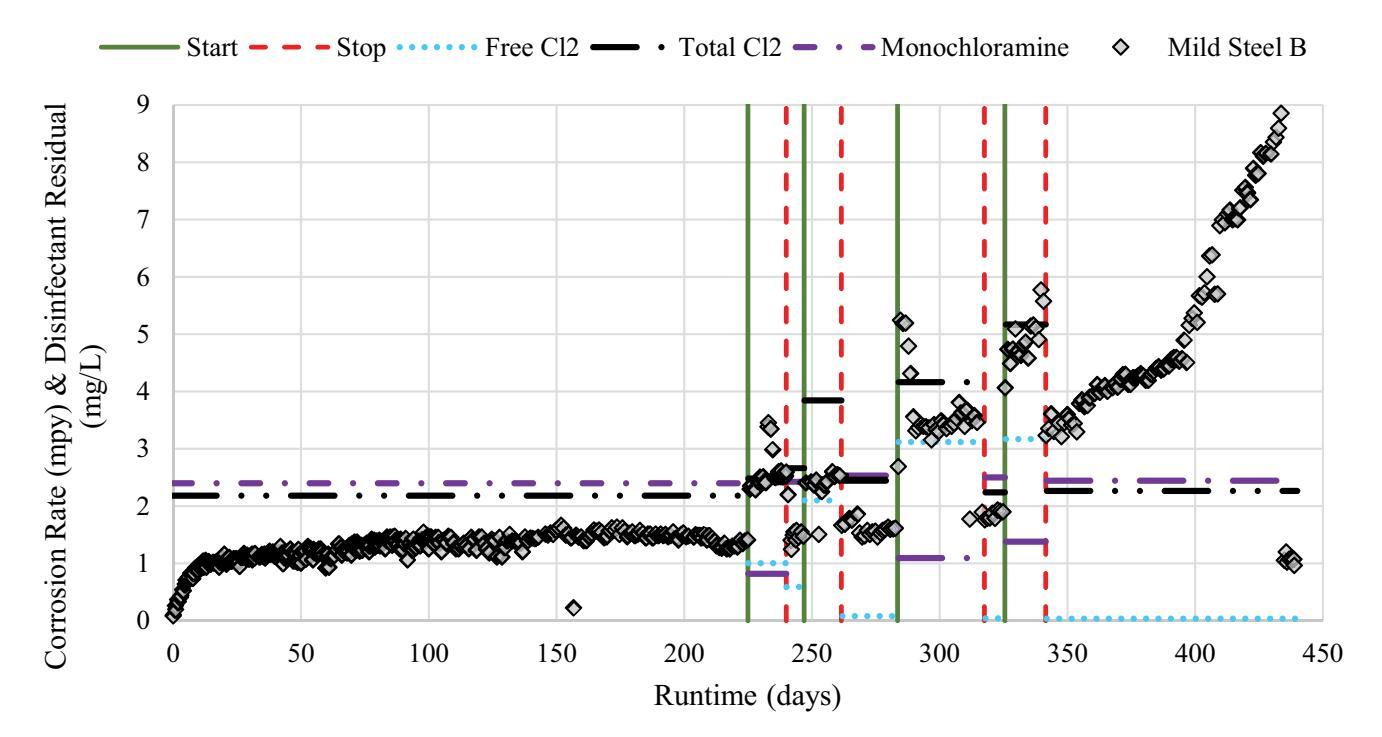
Fig. 8. Olinda mild steel LPR measurements.

For the Olinda WTP corrosion rack, baseline corrosion rates were established after approximately 120 d for the three metals studied. In addition to the unusually long time for a baseline to develop, the unusual shape of the copper baseline corrosion rate curve is believed to be attributed to the high organic acid content of the Olinda WTP finished water. It is believed that an organic layer formed around the copper probe and insulated the metal initially from the water's corrosivity. While this layer seems to have slowly been removed, it appears to have also aided in passivating the metal surface (along with common corrosion layer processes) to establish a baseline corrosion rate. This observation has been noted by others, where natural organic matter has been shown to inhibit the growth of the passivating layers and rather promotes the formation of amorphous hydrated surface films [9,10]. Average baseline corrosion rates were calculated to be 1.5 mpy for mild steel, 0.3 mpy for copper, and 0.4 mpy for lead solder for the chloramine system.

In total, four conversions to free chlorine cycles were conducted throughout the study at the Olinda WTP corrosion rack. The free chlorine conversion cycles lasted on average 19 d each. The post-disinfectant conversion cycles baseline took approximately 95 d to be established. The baseline took longer than expected to establish because the excessive tuberculation on the mild steel probes caused faulty readings and required the probe to be cleaned.

Changing disinfectant did not cause a change in the measured corrosion rates for the copper and lead solder metal probes. In comparison, the mild steel probe measured corrosion rate at least doubled each time the disinfectant type was switched to chlorine. The increased mild steel corrosion rate seemed to always be at or below the total chlorine residual concentration measurements. Although the mild steel corrosion rate returned to baseline levels after each conversion back to chloramine, the last disinfectant change cycle found that the corrosion rate did not return to baseline after the probes were exposed to approximately 5 mg/L of total chlorine residual. A new mild steel baseline, approximately 2.5 times higher than the original baseline, seemed to be reached but cannot be confirmed as the excessive tuberculation on the probe was causing interference with the LPR readings. The mild steel probe was removed, cleaned, and re-inserted and the corrosion rate measured for several days and found that the corrosion rate returned to the original baseline rate. The LPR data for the Olinda WTP corrosion study can be found in Fig. 8 for mild steel and Fig. 9 for copper and lead solder.

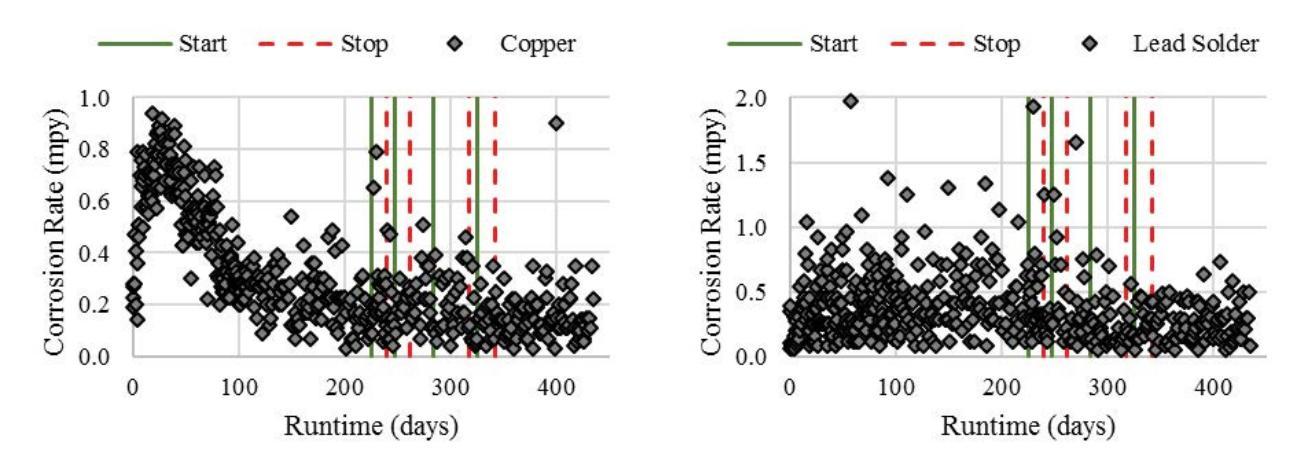
Fig. 9. Olinda cartridge brass (left) and lead solder (right) LPR measurements.

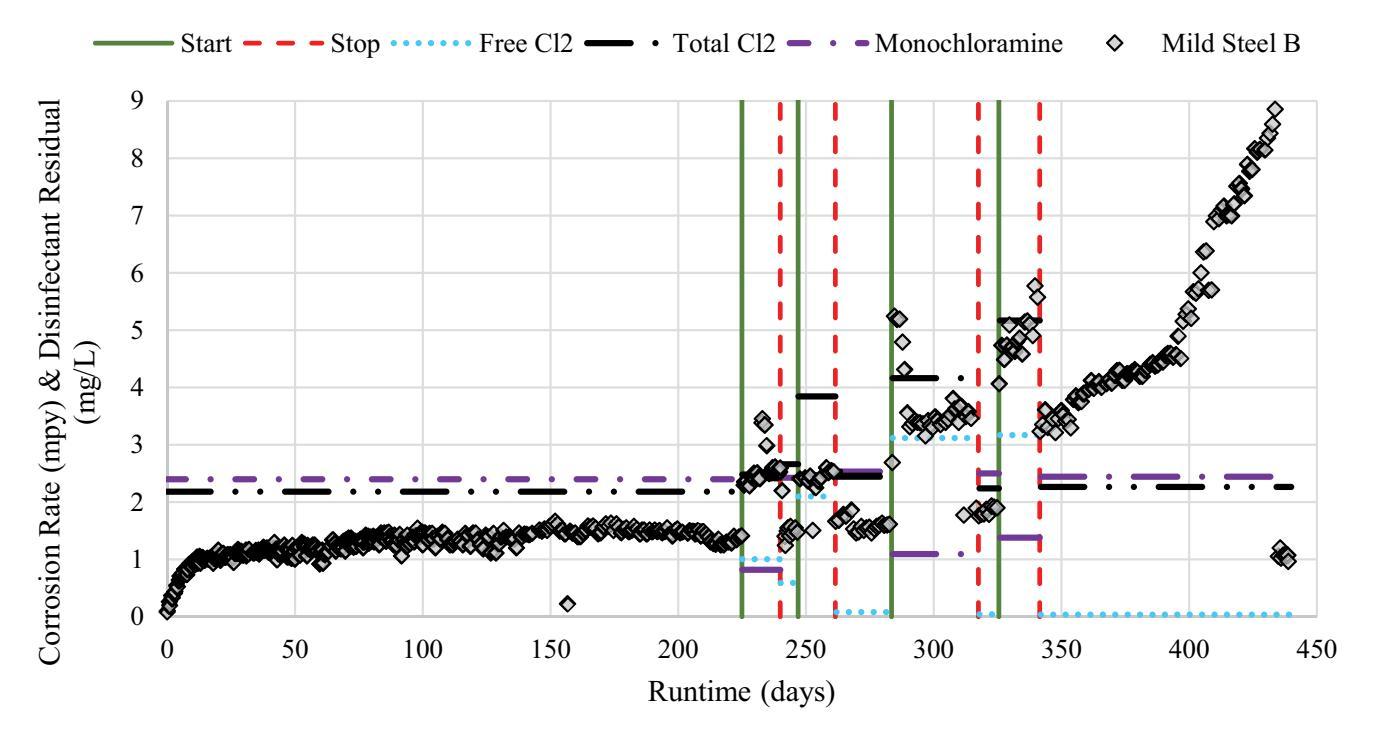
Fig. 10. Harry fields mild steel LPR measurements.

For the Harry Fields corrosion rack, baseline corrosion rates were established after approximately 90 d for the three metals studied. In comparison with the Olinda WTP corrosion rack results, a traditional shape for the copper baseline corrosion curve was observed. This was attributed to the lower organic acid content of the Pi'iholo WTP finished water. The mild steel baseline corrosion curve at the Harry Fields corrosion rack was found to be more erratic than the Olinda WTP corrosion rack. This behavior is thought to be related to the daily free chlorine residual concentration fluctuations at the Harry Fields site. Average baseline corrosion rates were calculated to be 1.8 mpy for mild steel, 0.4 mpy for copper, and 0.2 mpy for lead solder for the chlorine system.

Changing disinfectant did not cause a change in the measured corrosion rates for the copper and lead solder metal probes. In comparison, the mild steel probe measured corrosion rate increased by approximately 0.45 mpy each time the disinfectant type was switched to chloramine. Although the measured mild steel corrosion rate increased when the disinfectant was changed to chloramine, it returned to baseline levels after each conversion back to chlorine. The addition of soda to boost the pH to 8.8 during monochloramine conversion did not impact the increase in corrosion rate due to the change in disinfectant, nor the ability to return to baseline

corrosion rate level. Comparing the Harry Fields corrosion rack LPR data with the Olinda corrosion rack LPR data, on average, mild steel was 0.3 mpy higher, copper was 0.1 mpy higher, and lead solder was 0.2 mpy lower. The LPR data for the Harry Fields corrosion study can be found in Fig. 10 for mild steel and Fig. 11 for copper and lead solder.

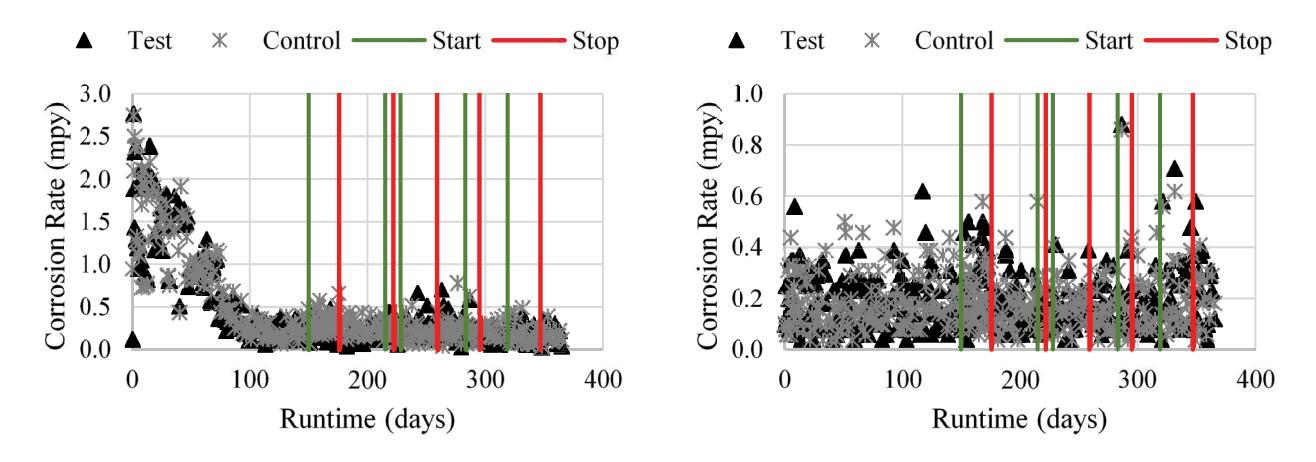
Fig. 11. Harry fields cartridge brass (left) and lead solder (right) LPR measurements.
